# FULL-SCALE STATIC AND DYNAMIC TESTING OF TIMBER FRAME HOUSES DAMAGED IN THE CHRISTCHURCH EARTHQUAKES

Hugh Morris<sup>1</sup>, David Carradine<sup>2</sup> and Minghao Li<sup>3</sup>

**ABSTRACT:** Very little research exists on total house seismic performance. This testing programme provides stiffness and response data for five houses of varying ages including contributions of non-structural elements. These light timber framed houses in Christchurch, New Zealand had minor earthquake damage from the 2011 earthquakes and were lateral load tested on site to determine their strength and stiffness, and preliminary damage thresholds. Dynamic characteristics were also investigated. Various loading schemes were utilised including quasi-static loading above the foundation, unidirectional loading through the floor diaphragm, cyclic quasi-static loading and snapback tests. Dynamic analysis on two houses provided the seismic safety levels of post-quake houses with respect to local hazard levels. Compared with New Zealand Building Standards all the tested houses had an excess of strength, damage is a significant consideration in earthquake resilience and was observed in all of the houses. A f

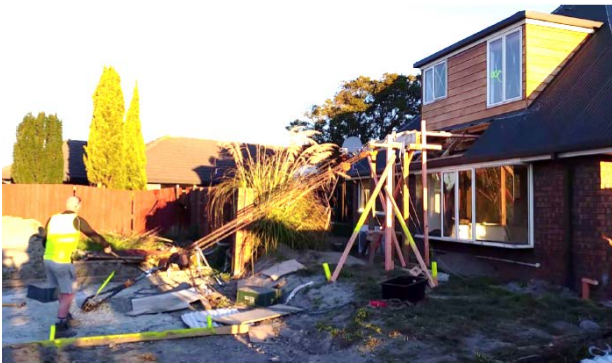
**Figure 1:** Uni-directional 1993 house snapback test side view.

The final test house was loaded uni-directionally using two 7.5T chain blocks (hand winches) attached to a separate concrete foundation (Figures 1-3) and over a pivoting frame through into the first floor diaphragm. The rigidity of the final 2014 load system was increased for this final uni-directional 1993 house test where a reinforced concrete foundation beam and slab were fixed to six screw piles, as shown in Figure 2.

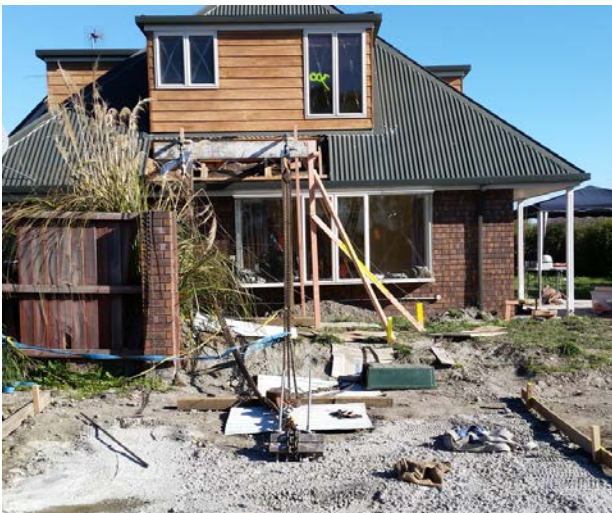
**Figure 2:** Uni-directional 1993 house snapback test front view showing anchor into slab, sub-slab beam and piles.

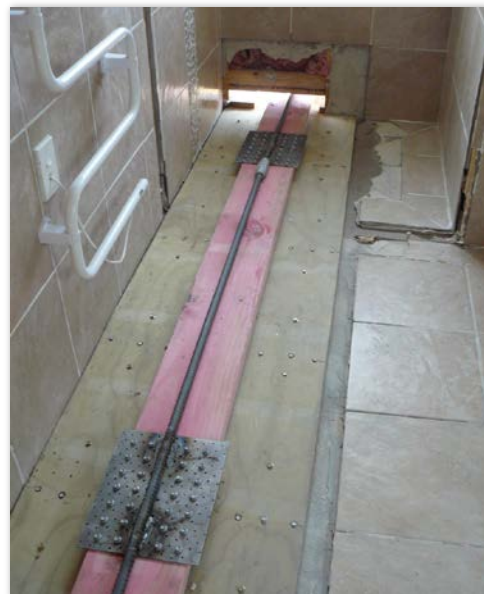
**Figure 4:** Uni-directional 1993 house snapback test – anchor system into timber floor diaphragm.

The load system was anchored to two lengths of Reidbar that ran the length of the house and were fastened along their length to 190x45mm timber members. This was then fastened to 20mm thick plywood sheets and attached to the floor at regular intervals to ensure the load distribution was as even as possible. (Figures 3,4)

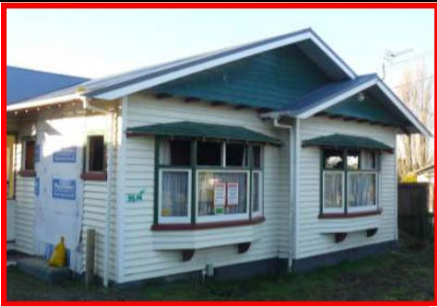
| <b>TABLE 1a</b> | <b>1923 – RETREAT ROAD</b> |

| <b>TABLE 1a</b> | <b>1923 – RETREAT ROAD</b> |
|---|---|
| <b>1 Cladding</b> | Weatherboard |
| <b>2 Lining</b> | Plaster on lath |
| <b>3 Floor</b> | Suspended floorboards on piles |
| <b>4 Foundation</b> | Small upstand on concrete perimeter foundation |
| <b>5 Year &amp;Test</b> | 2013 Hydraulic cyclic & snap-back |
| <b>9 Stiffness / Period</b> | 3.8 kN/mm / 0.29s |
| <b>10 Damping</b> | >15% |

The 1923 house used the most sophisticated bi-directional hydraulic load system and achieved maximum loads for the structure of the house. The reaction system used piles and 10 tonne cast concrete pile cap beams which restricted the movement of the reaction frame to about 15mm for 250kN maximum load.

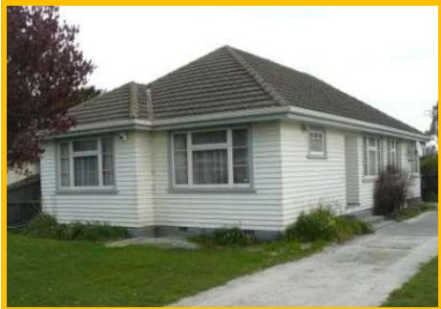
| <b>TABLE 1b</b> | <b>1947 - BEXLEY ROAD</b> |

| <b>TABLE 1b</b> | <b>1947 - BEXLEY ROAD</b> |
|---|---|
| <b>1 Cladding</b> | Weatherboard |
| <b>2 Lining</b> | Fibrous plaster & light timber panelling |
| <b>3 Floor</b> | Suspended floorboards on piles |
| <b>4 Foundation</b> | Concrete perimeter foundation |
| <b>5 Year &amp;Test</b> | 2012 - Diagonal uni - directional |
| <b>9 Stiffness / Period</b> | 9.0 kN/mm / 0.23s* |

The 1947 house was next tested and uni-directionally loaded from one end. This house had residual compression in the framing and it was clear that bi-directional test loading needed to be from the middle of the house.

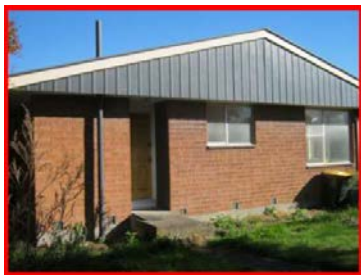
| <b>TABLE 1c</b> | <b>1970 - CARDRONA STREET</b> |

| <b>TABLE 1c</b> | <b>1970 - CARDRONA STREET</b> |
|---|---|
| <b>1 Cladding</b> | Brick Veneer |
| <b>2 Lining</b> | Gypsum board linings |
| <b>3 Floor</b> | Suspended floorboards on piles |
| <b>4 Foundation</b> | Concrete piles, concrete perimeter foundation |
| <b>5 Year &amp;Test</b> | 2013 - Hydraulic cyclic & snap-back |
| <b>9 Stiffness / Period</b> | 7.5-8kN/mm / 0.20s |
| <b>10 Damping</b> | >6% (10% by int walls) |

The 1970 house test was bi-directionally loaded with props to a central beam and used a hydraulic load system. A lightweight beam across the house was assembled in parts within the ceiling space. It was extremely difficult to install in the restricted ceiling space and the load was limited by anchorage within the house and the reaction system.

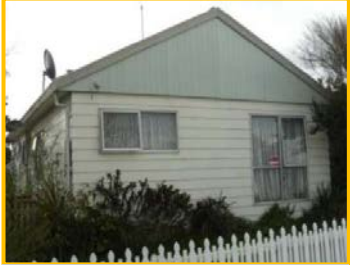
| Table 1d | 1983 –WAIROA STREET |

| Table 1d | 1983 –WAIROA STREET |
|---|---|
| 1 Cladding | Light fibre cement boards |
| 2 Lining | Gypsum board linings |
| 3 Floor | Suspended particle board on piles |
| 4 Foundation | Timber piles |
| 5 Year &Test | 2012 - Diagonal unidirectional |
| 9 Stiffness / Period | 18kN/mm / 0.14s* |

The 1983 house test was a simple test on a very simple regular house uni-directionally loaded at one end with chain blocks and reacted from the opposite end above the foundation. It gave useful results and provided confidence to pursue further tests.

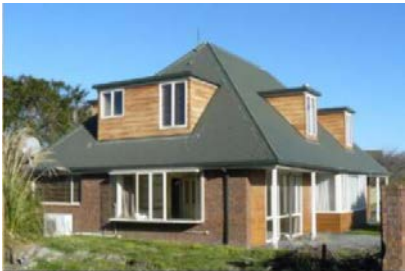
| Table 1e | 1993 -NORCROSS STREET |

| Table 1e | 1993 -NORCROSS STREET |
|---|---|
| 1 Cladding | Part brick veneer, part light fibre cement boards, solid brick garage boundary wall |
| 2 Lining | Gypsum board linings |
| 3 Floor | Particle board on timber joist upper floor |
| 4 Foundation | Slab on grade lower floor |
| 5 Year &Test | 2014 - Unidirectional & snap– back |
| 9 Stiffness / Period | 27 kN/mm / 0.14s |
| 10 Damping | 2% ambient, ~6% hammer |
